Waverley Borough Council

# Weydon Lane Landfill, Farnham

Updated site maintenance and management plan

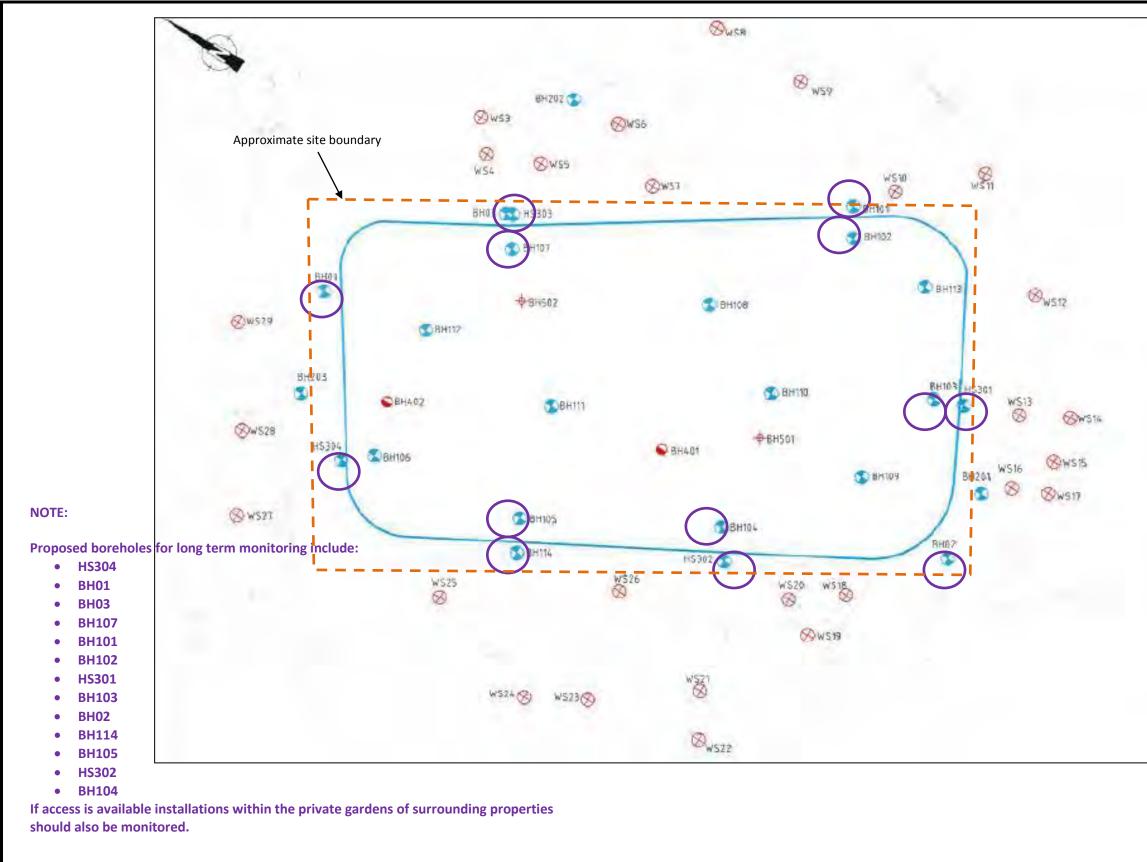
Client	Project
Waverley Borough	Weydon Lane Landfill, Farnham
Council	
CGL	Title Long term monitoring points

טא מ א	CG/5934	C
b No		]
WS23: WS24 WS25 WS26 WS26 WS28 WS28 WS28 WS28	24 PILGRIMS CLOSE 24 PILGRIMS CLOSE 27 PILGRIMS CLOSE 5 PILGRIMS CLOSE 12 PILGRIMS CLOSE 19 WEYDON LANE 13 WEYDON LANE 5 WEYDON LANE	
WS8 WS9 WS108 11 WS12* WS138 14 WS15 WS168 17 WS18 WS198 20 WS218 22	33 TALBOT ROAD 41 TALBOT ROAD BRAMBLETON HALL 50 UPPER WAY 42 UPPER WAY 36 UPPER WAY 36 UPPER WAY 49 BALBRCYS 47 BALDREYS 19 PILGRMS ELOSE	
WS2 W5384 W55 W55 W55 W57	5 TALBOT ROAD 25 TALBOT ROAD 34 TALBOT ROAD 46 TALBOT ROAD 52 TALBOT ROAD	
HS302 HS303 HS304 W\$1	UNKNOWN SU83613,45822 SU83488,45826 2 TALBOT ROAD	
8H112 8H118 8H116 H5301	UNKNOWN UNKNOWN UNKNOWN SUB3643,45628	
8H108 8H109 8H1104 8H1104 8H1104	UNKNOWN SU83596,45646 UNKNOWN UNKNOWN	
BH103 BH104 BH105 BH106 BH107	UNKNOWN SUB3848,45646 UNKNOWN UNKNOWN UNKNOWN	
8803 8802 8803 88101 88102	SU83L68,45619 SU83590,45603 SU83613,45822 SU83544,45872 UNKNOWN	
BH402 BH501 BH582	SU83563,45714 SU83520,45818 SU83588,45683 SU83584,45749
